**KOMITE NASIONAL KESELAMATAN TRANSPORTASI  
REPUBLIC OF INDONESIA**

## **Aircraft Accident Investigation Report**

**PT Trigana Air Service**

**ATR 42-500; PK-YSP**

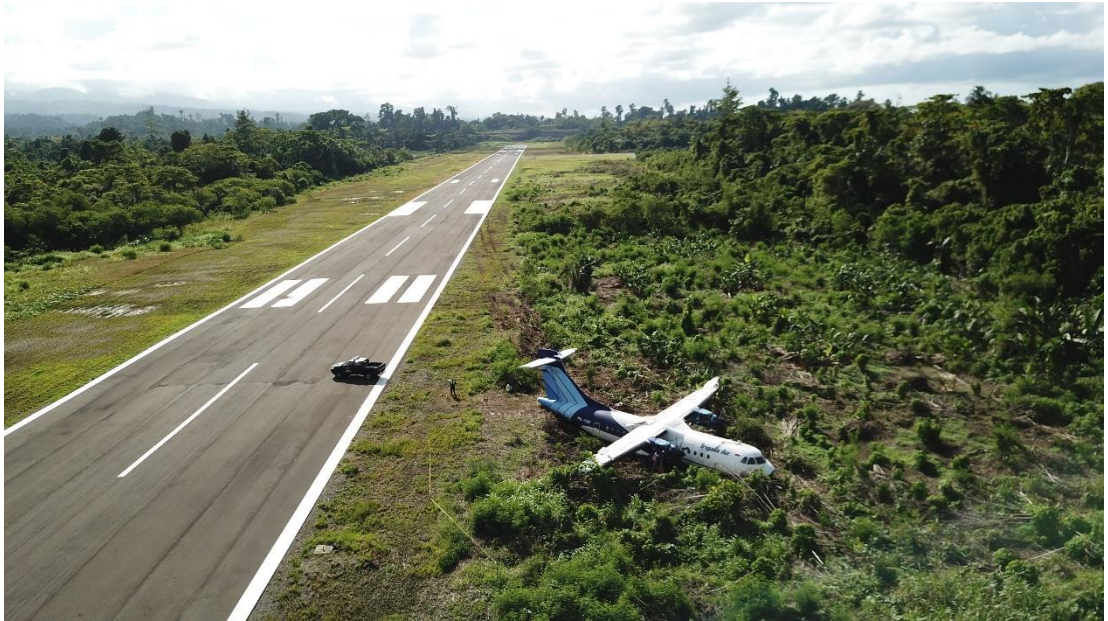
The engines power was increased and the aircraft started the takeoff roll. The aircraft speed continued increasing to about 100 knots, when the PIC noticed that the engines had abnormal condition. The PIC decided to cancel the take-off by retarding the power levers and selected to reverse. The aircraft then veer to the left out of the runway and stop about 1,200 meters from the beginning Runway 28.

**Figure 1: The aircraft condition after stop**

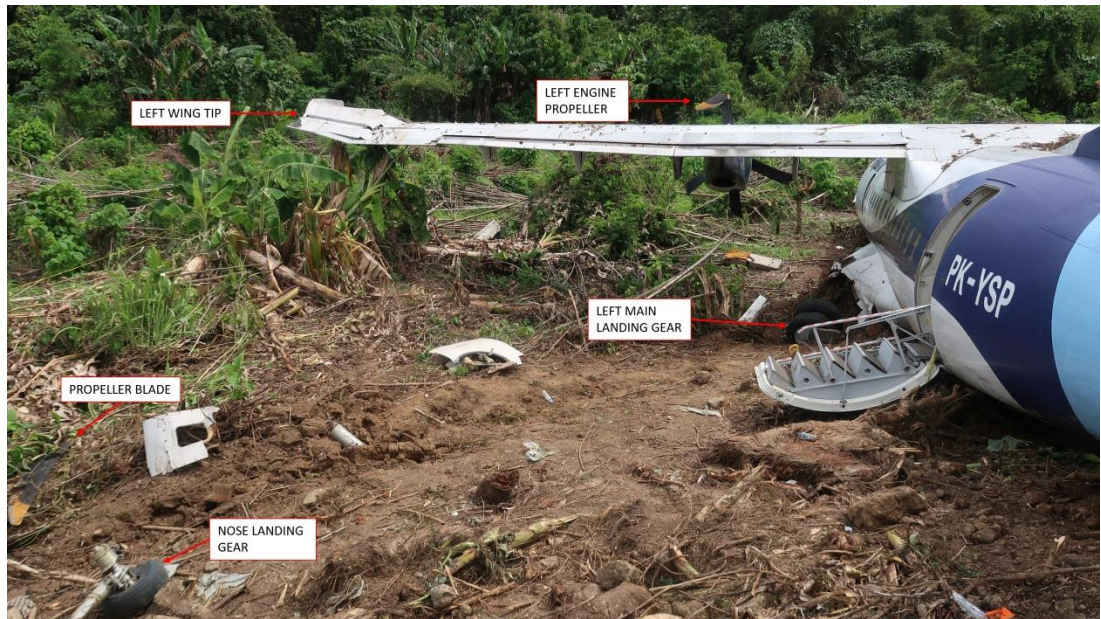
All landing gears and the left engine propeller blades were broken. Left wing tip bent. The fuselage skin on the aft of cockpit section wrinkle. On the cockpit area, the central and pedestal panels was pulled backward. The instrument panel removed from its mountings, indicating a high impact.

**Figure 2: The aircraft Wreckage**

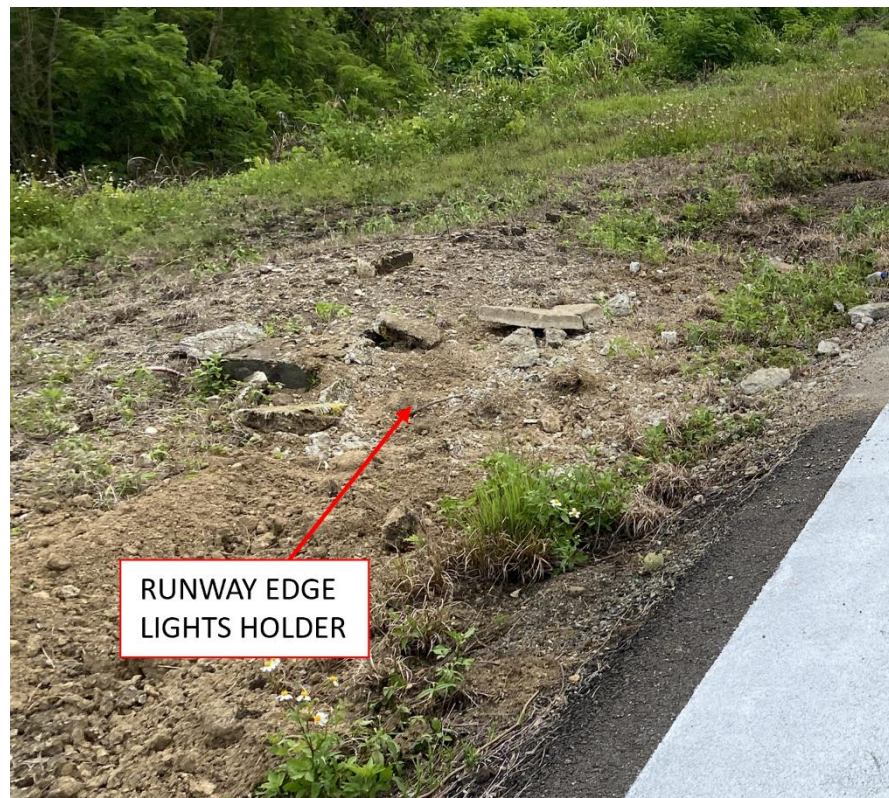
One of the runway edge lights was broken.

**Figure 3: The damage of runway edge lights**

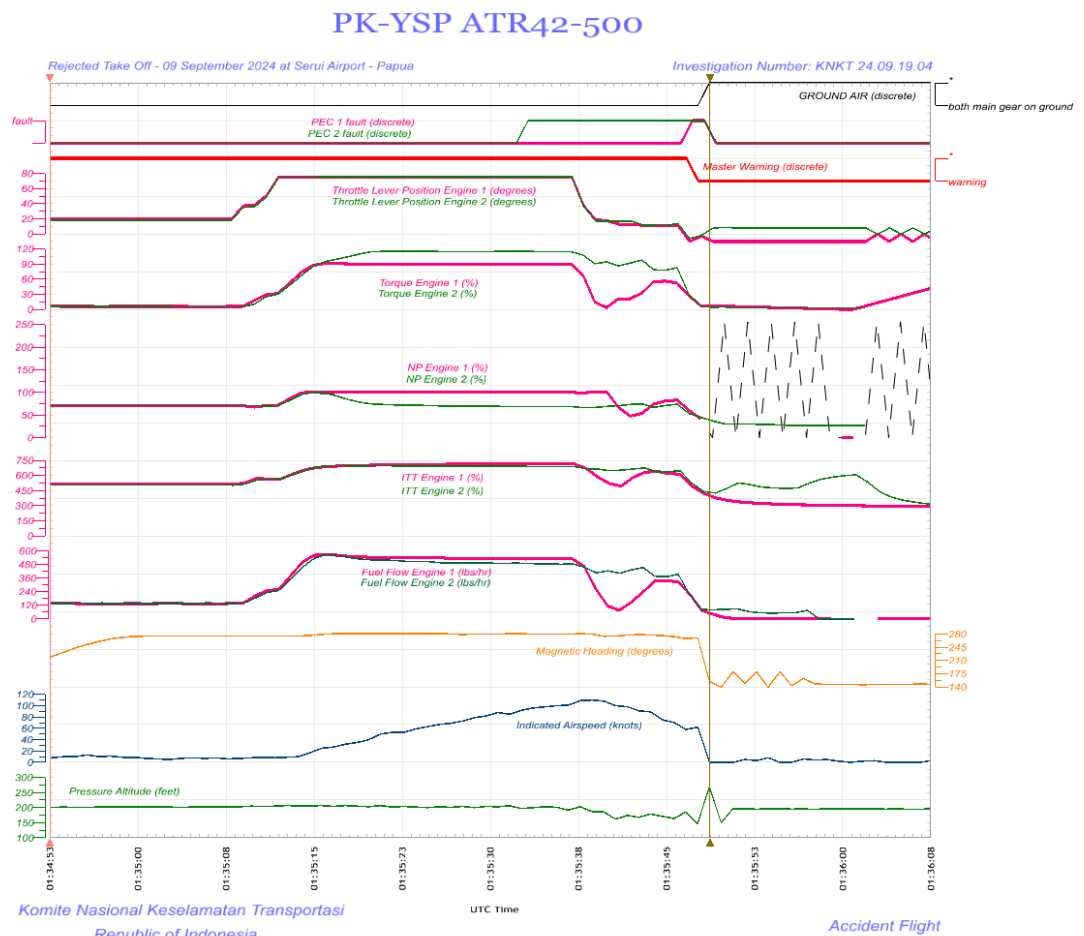
**Figure 5: The relevant parameters of the FDR**

1. At 10:35:09 LT, the take-off was initiated, indicated by increasing throttle levers position engine 1 to 37 degrees and engine 2 to 35 degrees, one second later the torque of both engines increased.
2. At 10:35:15 LT the aircraft started the take-off roll indicated by the increasing of the indicated airspeed.

4. At 10:35:17 LT, the torque of engine number 1 decreased to 90% while the torque of engine number 2 passed 100% and continued increasing to maximum 116%.

When the pilot advanced both power levers to the notch, engine torque and NP increased as expected. After that, right engine torque continued increasing to a maximum of 116 percent, while left engine torque remained at 90 percent. At the same time, NP of the right engine dropped to 72 percent while NP of the left engine remained at 100 percent. The pilots did not notice the difference in torque and NP values between the two engines, until the aircraft speed about 100 knots. The takeoff procedure in the FCOM states that the FO must monitor the engine parameters. Failure to monitor the engine parameters during takeoff could lead to unidentified any engine abnormality.

Therefore, KNKT recommends the Trigana Air Service to ensure the take-off procedure is carried out by all pilots.

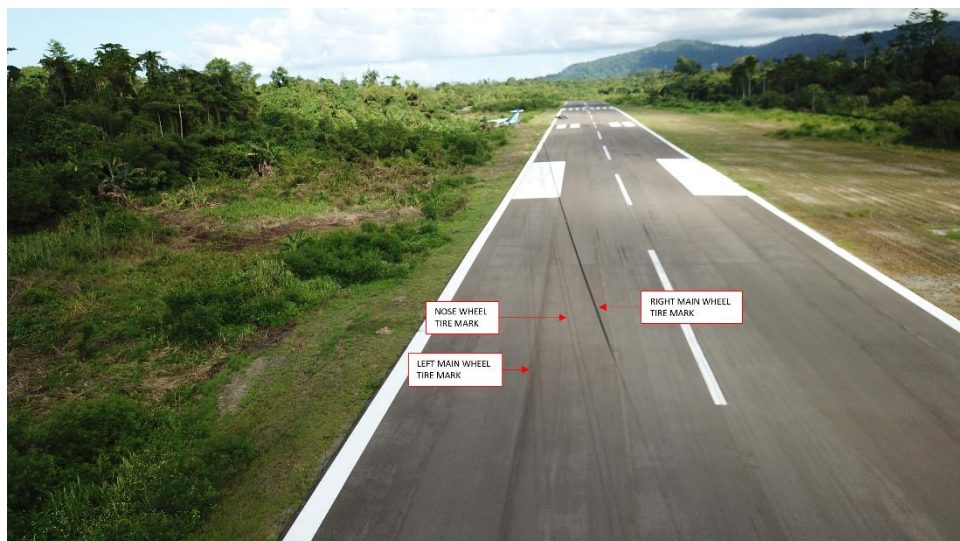
The aircraft tire marks were found on the runway started about 840 meters from the beginning Runway 28, which was identified as right main wheel mark. About 5 meters from right main wheel mark, the left main wheel mark appeared followed by the nose wheel tire mark about 57 meters from the first tire mark. Since then, the tire marks started veer to the left of the runway centerline. The tire marks started exit the runway about 1,100 meter and the aircraft stop at 1,200 meters from the beginning Runway 28.

**Figure 6: The aircraft tire marks on the runway**
