**KNKT Immediate Safety Recommendation**  
**Aircraft Serious Incident Investigation**  
**PT Sayap Garuda Indah, Bell 407, PK-ZGL**  
**Denpasar, 4 May 2026**

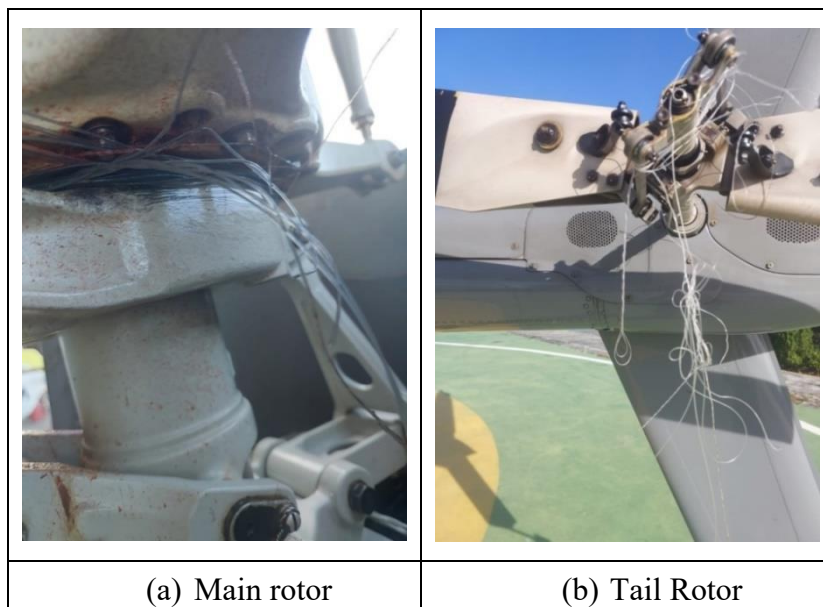
At approximately 1612 LT, the helicopter landed at Bena. Following engine shutdown, the pilot and maintenance engineer conducted a post-flight inspection of the helicopter. During the inspection, kite string material was found entangled around the pitch link and tail rotor mast area.

**Figure 2: Kite string entanglement on PK-ZGL helicopter**

There were no injuries to the pilot or passengers during the occurrence. No damage to the aircraft was identified during the ground inspection.

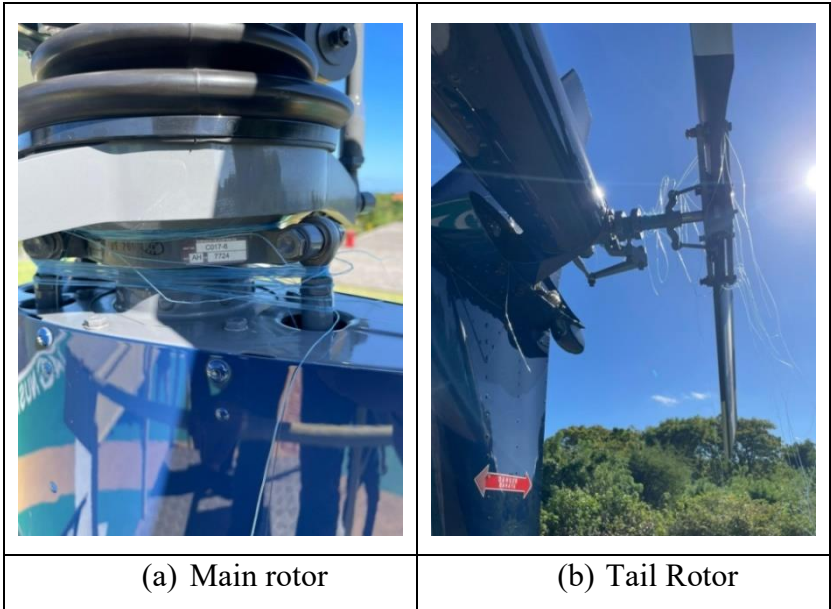
Upon completing the sightseeing flight, the helicopter returned to JAG Helipad. During the approach and landing, the pilot did not observe any kites in the vicinity of the flight path. Following landing, maintenance and ground support personnel discovered kite-string material entangled around the main rotor pitch link and tail rotor assembly. The occurrence resulted in minor damage to the helicopter. No injuries were reported.

**Figure 4: Kite string entanglement on PK-VPY helicopter**
