**NATIONAL TRANSPORTATION SAFETY COMMITTEE**  
**REPUBLIC OF INDONESIA**

**FINAL**  
**KNKT.16.11.15.03**

**Marine Accident Investigation Report**  
**Collision between Cargo Ship *TAY SON 4* (IMO 9370587)**  
***and Fishing Vessel *MULYA JATI****  
**Tuban Waters, East Java**  
**Republic of Indonesia**  
**19 November 2016**

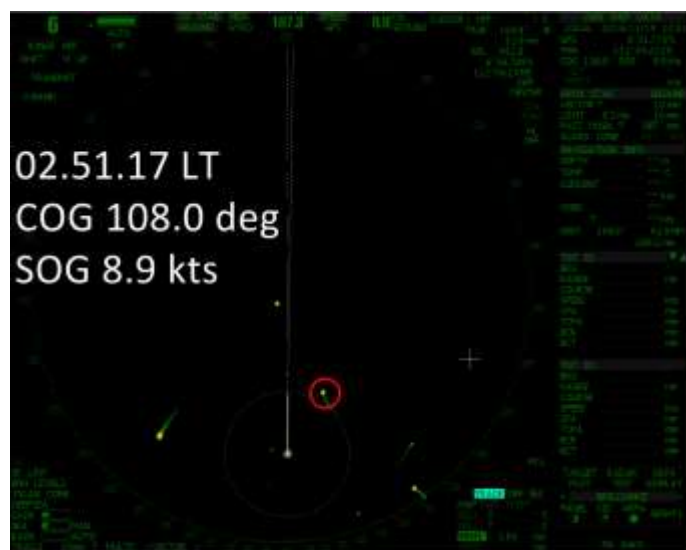
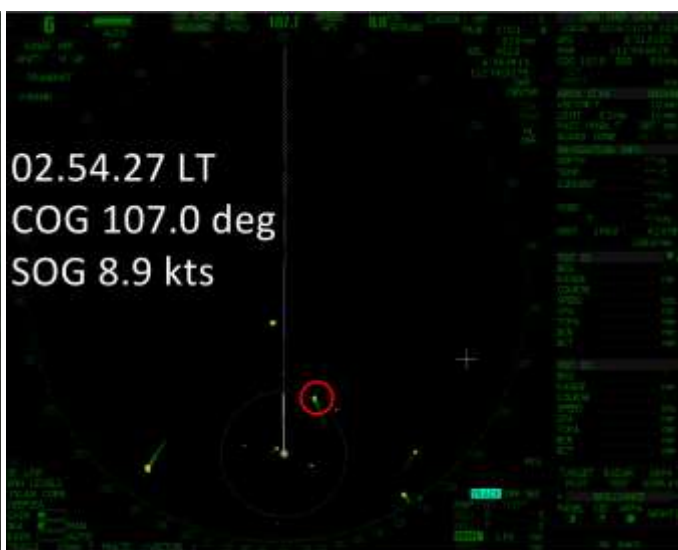
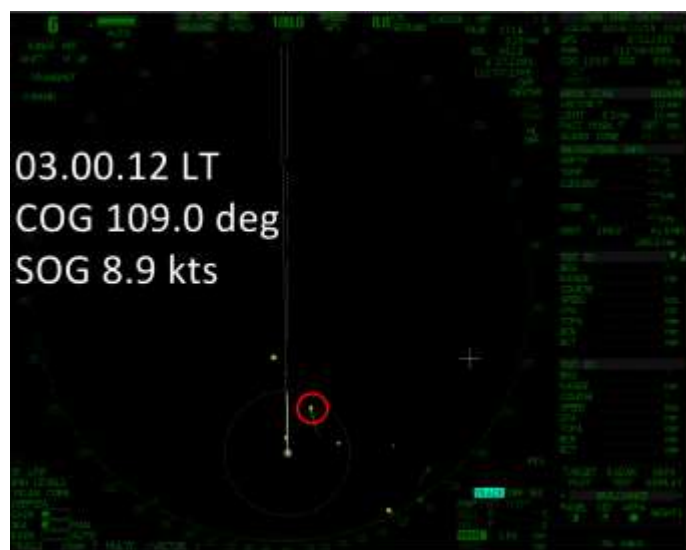
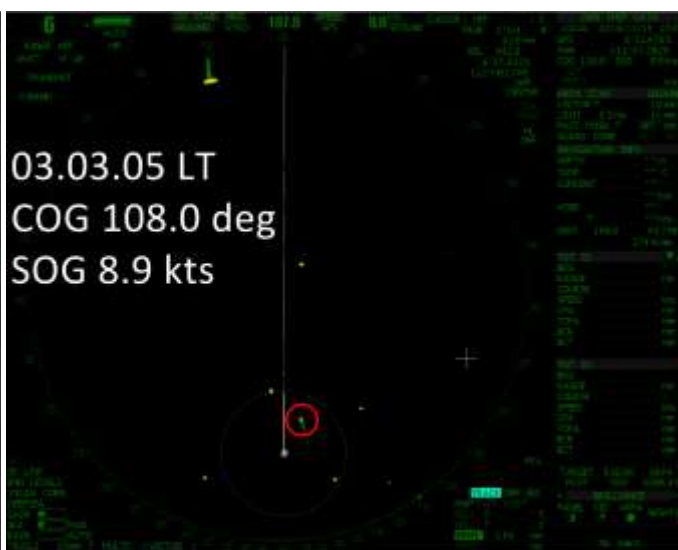
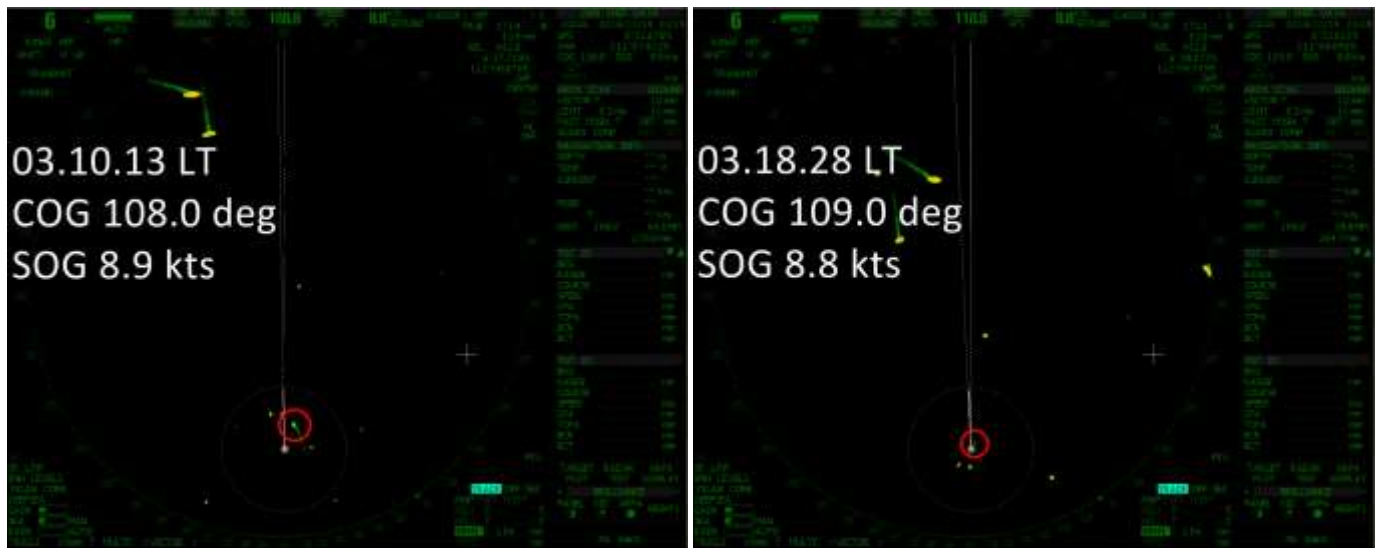
**Figure 1: Mulya Jati (red circle) on Tay Son 4's radar (in sequential order)**

At about 02.54 LT, an object appeared in the radar image at the range of 1.5 NM and bearing of 30°. The object, later known as the *Mulya Jati*, did not have any identification as appeared on AIS target data, but was moving with her heading approximately 080°.

At about 03.00 LT, the object was getting closer with the range of 1.3 NM and bearing of 27°. There was still no change on either the *Tay Son 4*'s or *Mulya Jati*'s heading. At that time, the speed over ground of *Tay Son 4* was around 9 knots, while the longitudinal water speed was around 7 knots.

At about 03.10 LT, both the *Tay Son 4* and the *Mulya Jati* were approaching each other with the distance was around 0.7 NM. Both vessels kept their headings.

At about 03.18 LT, when the *Mulya Jati* was around 0.2 NM from the *Tay Son 4*, she steered her heading a little bit to approximately 090°. Afterwards, the *Mulya Jati* kept their heading approaching the *Tay Son 4*.

The only reason behind this accident was the lookout duty. The crew members on duty of *Tay Son 4* did not pay serious attention to the surrounding not even observing the radar. The *Tay Son 4*'s X-band radar had detected the moving target (*Mulya Jati*) which was on the starboard bow from beginning. They were talking about many topics other than the surrounding situation until they were late to realise about an object very close to the *Tay Son 4*. Actually, the crew of *Tay Son 4* could recognise the fishing vessel through radars. Even though the radars will not show the identification of the *Mulya Jati*, such as name, speed, heading of vessel and others, the crew could track the movement of an

However, the moving target was not plotted on the *Tay Son 4*' radar which had ARPA capability. There was 20 minutes before the accident for the navigating Officer of *Tay Son 4* to make an evasive manoeuvre to avoid collision since the moving target (*Mulya Jati*) had reached 1.5 NM set VRM. According to the COLREGs, the *Tay Son 4* should give way to allow *Mulya Jati* to keep a steady course and speed.

Nonetheless, the image radar at the sequence of event shows that *Tay Son 4* changed its course to port (from COG 108° to 101°) during period from 03.12 to 03.14 LT with distance to moving target approximately 0.5 nm. Then the vessel swung back to starboard (from COG 101° to 110°) during period from 03.14 to 03.18 LT. Shortly after, the vessel heading was changed rapidly to port, in which seemed the steering mode has switched to hand/manual.

To increase the awareness amongst the crew of *Tay Son 4*, the guard ring feature on the radar could be activated. This allows the radar to warn the crew if an object is approaching the *Tay Son 4* within the range set up.

1. To ensure the crew members on duty always maintain proper lookout by involving navigational equipment such as radars and AIS, particularly to ensure safe navigation.

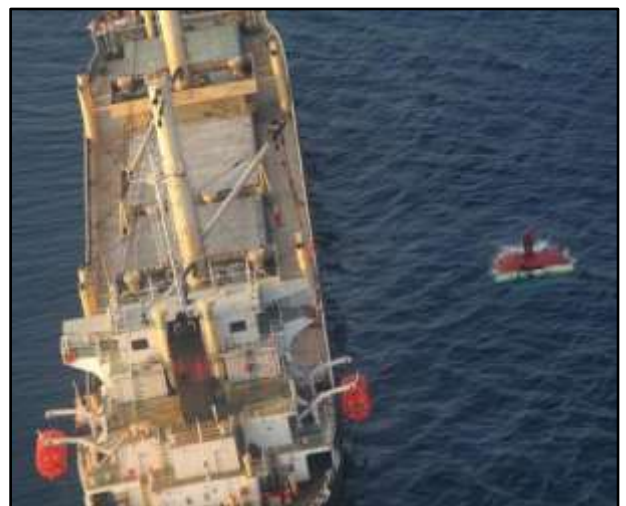
**Figure 2: Mulya Jati after the collision**

The survived crew of *Mulya Jati* were divided into two groups. Each group members were sitting on the floating wreckage and waited for some help.

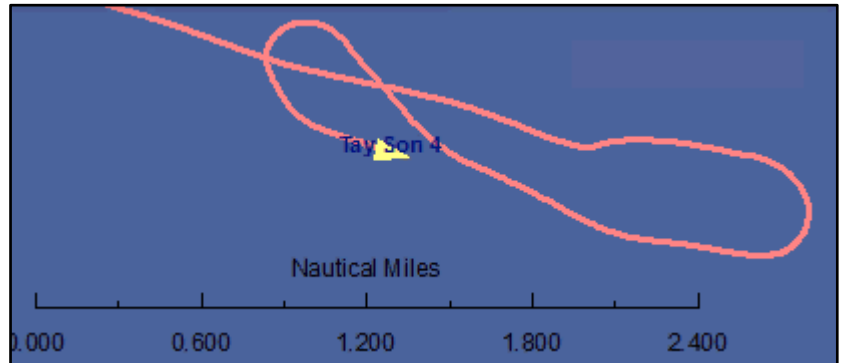
Figure 3: Turning circle of *Tay Son 4* in evacuating crew of *Mulya Jati*

Shortly after, the *Tay Son 4* made a turning circle manoeuvre to assist the crew of *Mulya Jati*. At the first turning circle, the *Tay Son 4* missed a group of survivors. Since the group yelled to the *Tay Son 4*, the *Tay Son 4* made another turning circle. About one hour after the collision, the *Tay Son 4* dropped her anchor as well as deployed lifebuoys, two lifeboats and a rescue boat to evacuate a group of survivors floating on a wreckage.

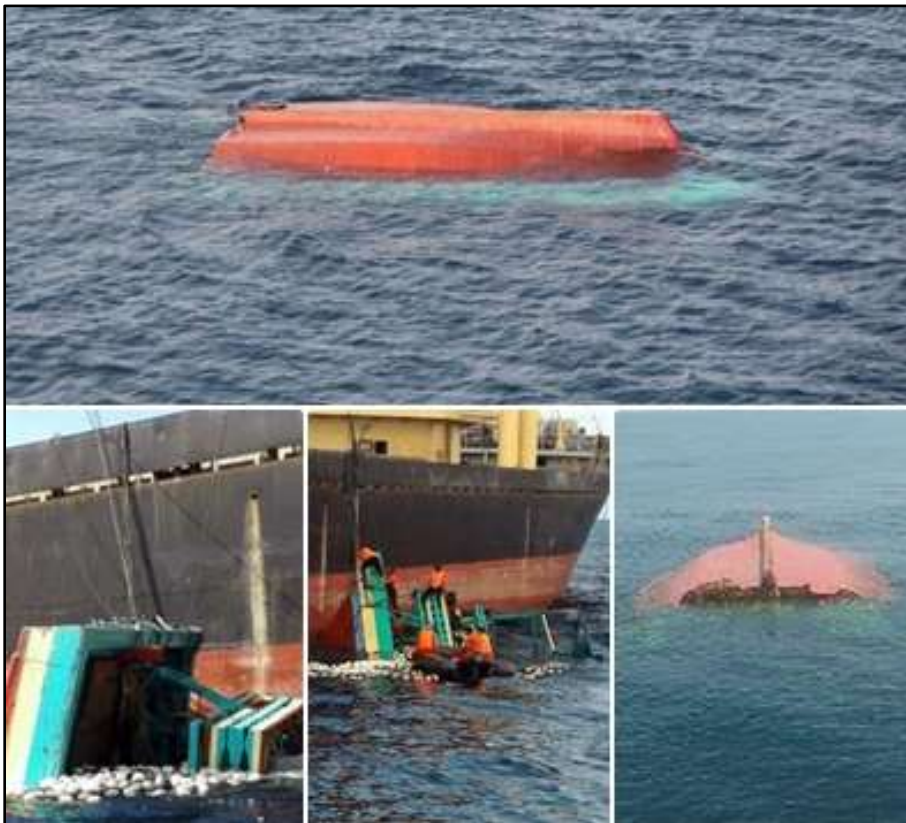
Figure 4: *Mulya Jati* was broken apart

As the result of the accident, *Mulya Jati* was broken into two parts. About one week later, the floating wreckages of *Mulya Jati* were found in Rembang Waters, Central Java. However, there was no sign of survivors in alive or death in the wreckages.
