# **FINAL REPORT**

**Marine Accident Investigation Report**

**Grounding of *Young Yong* (IMO 9194127)**

**26 October 2022**

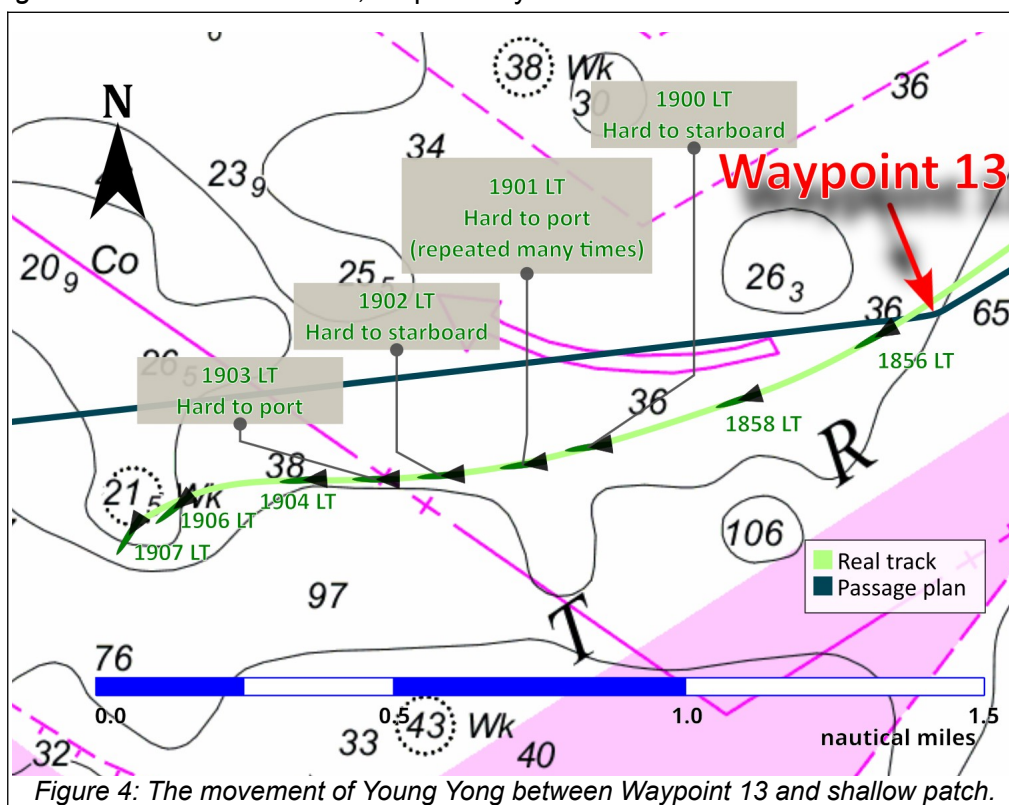
Figure 4: The movement of *Young Yong* between Waypoint 13 and shallow patch.

At about 1857 LT, the Master ordered the AB1 to change the course to 270°. The heading and speed of *Young Yong* were 247° and 7.8 knots, respectively.

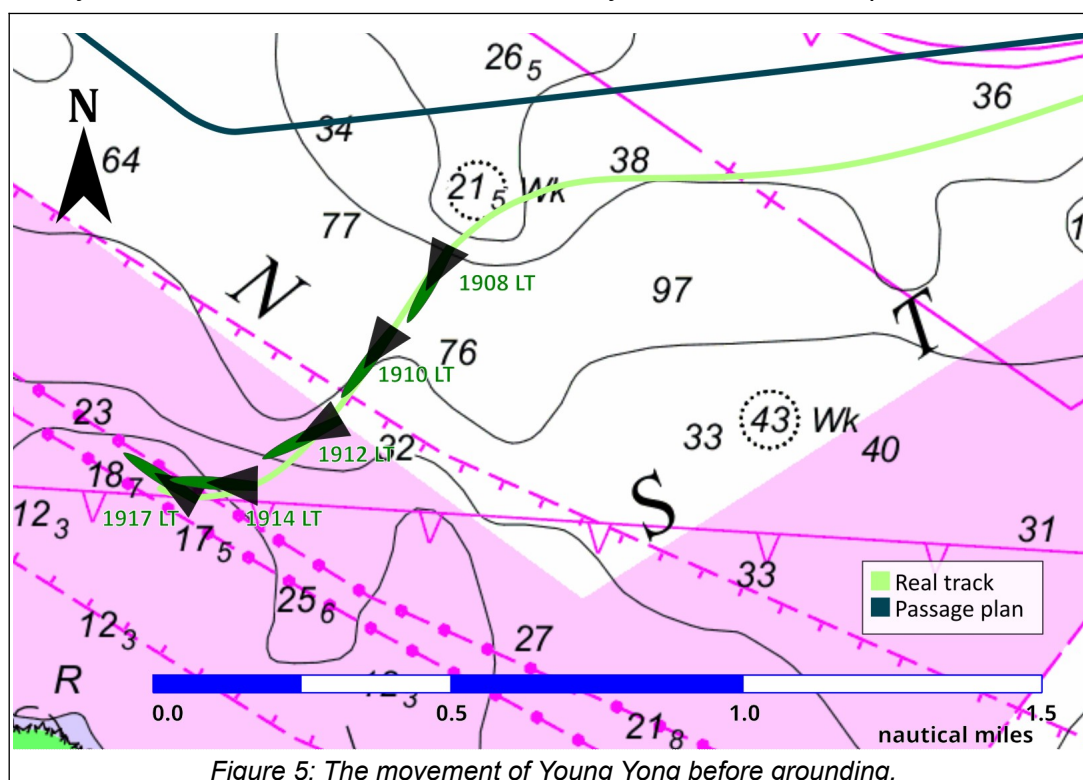
Figure 5: The movement of *Young Yong* before grounding.

At 19.07 LT, the VTIS West asked the container vessel to reduce her speed and keep a safe distance from *Young Yong*. At the time, the heading and speed of *Young Yong* were 214° and 5.6 knots, respectively.

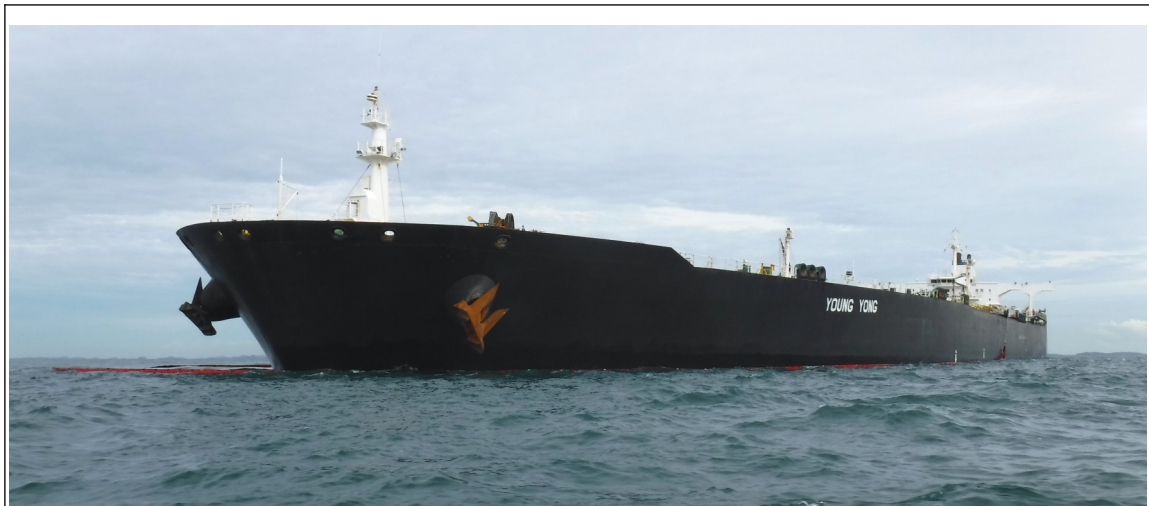
*Figure 6: Young Yong whilst aground.*

At about 19.17 LT she ran aground at the coordinates of 1.1278233° N and 103.7155983° E.

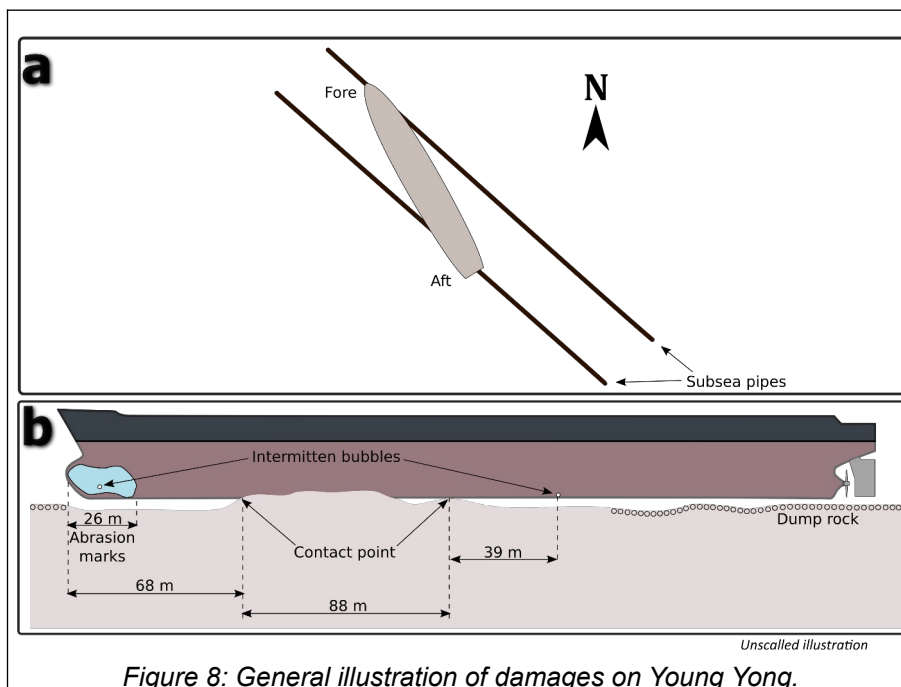
Based on the accident report made by *Young Yong* Master, the water ingress into some areas due to damage on fore peak tank 1P and 2P. Furthermore, her hull structure at 3P, 4P and 5P also deformed (some photos are attached in the appendix).

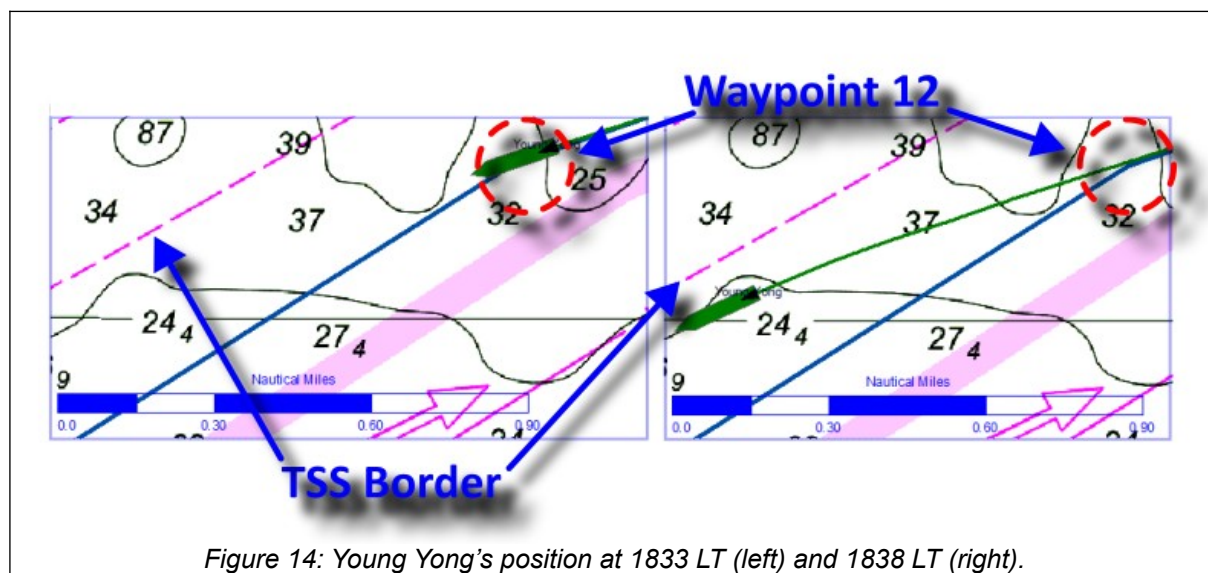
Figure 14: *Young Yong*'s position at 1833 LT (left) and 1838 LT (right).

At about 18.33 LT, the movement of *Young Yong* showed that she was at the Waypoint 12 of her Passage Plan. Several minutes later, she exceeded the leg and approached the TSS border (dash line in Figure 14).

From the recorded conversation, at about 1835 LT the VTIS Officer warned *Young Yong*. Afterwards, the Master began to order the AB to take a port turn (following the leg) where *Young Yong*'s heading was about  $251^\circ$  and she was off from the Waypoint 12. Because the position and heading did not show significant change, the Master repeated his order several times with various heading intended to go to port in the next two minutes. Until at about 1843 LT, finally her heading ( $235^\circ$ ) was approximately parallel with the Passage Plan, but her position was off about 0.2 NM from her Passage Plan. In this situation, she was too close to the TSS border for several minutes. In the end, The Master ordered the AB to change the course after he received advice from the VTIS Central.

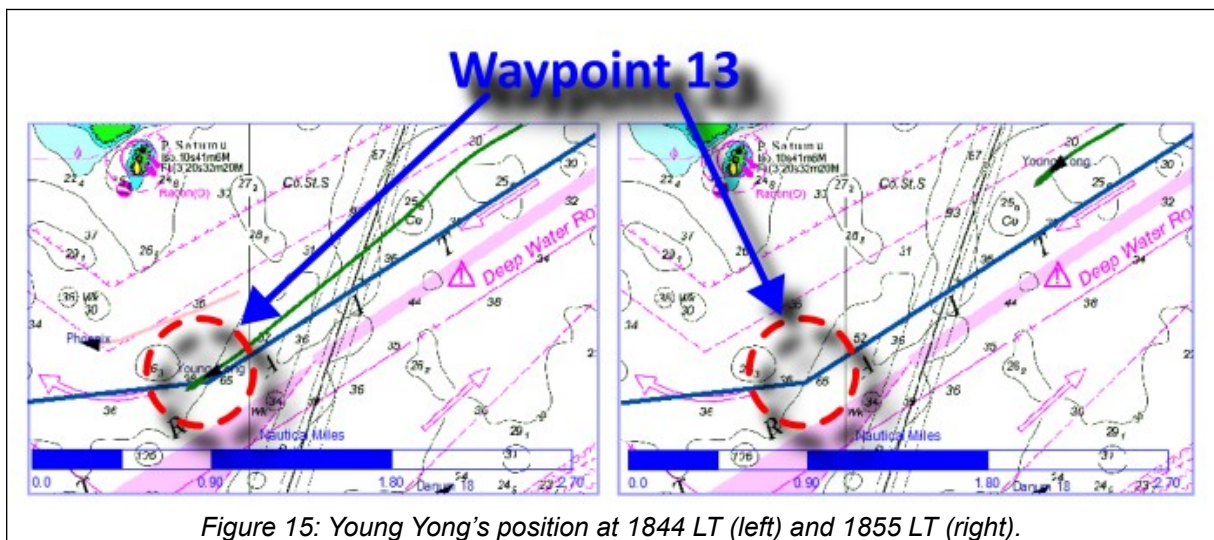
Figure 15: *Young Yong*'s position at 1844 LT (left) and 1855 LT (right).

At about 1844 LT, the Master began to order the AB to change the course to starboard in preparing an alteration of heading at the Waypoint 13. However, until *Young Yong* passed the Waypoint 13 at about 1855 LT, there was only about 10° of heading change obtained.

From this situation, it is highly likely that the ECDIS had not been optimised to assist the NOOWs during navigation. Should the ECDIS be used at the time, the Master would know when to alter the heading and how much degree had to take to follow the Passage Plan safely. This could have happened along the passage from the beginning of the voyage.

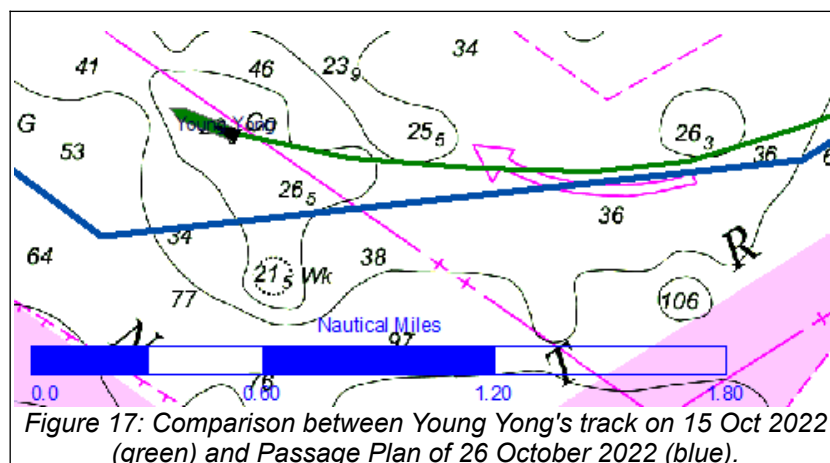
In the previous trip from EOPL to the Port Klang (Figure 17), it is likely that the situational awareness worked well. The track of Young Yong shows that the heading alteration around the shallow patch was done without any issue. Having looked at their roster<sup>17</sup> (see Error: Reference source not found) at about 1404 LT during that trip, the NOOWs were 2/O and assisted by another AB and Bosun in which they were not really much different in terms of their age. In that circumstance, situational awareness seemed to ran effectively due to the age gap amongst them was insignificant. In contrast, the circumstance prior to the accident (roster period of 1600-2000) shows the opposite situation.
