**KOMITE NASIONAL KESELAMATAN TRANSPORTASI  
REPUBLIC OF INDONESIA**

## **KNKT.18.06.25.04**

### **Aircraft Serious Incident Investigation Report**

**ATR 72-212; PK-WHF**

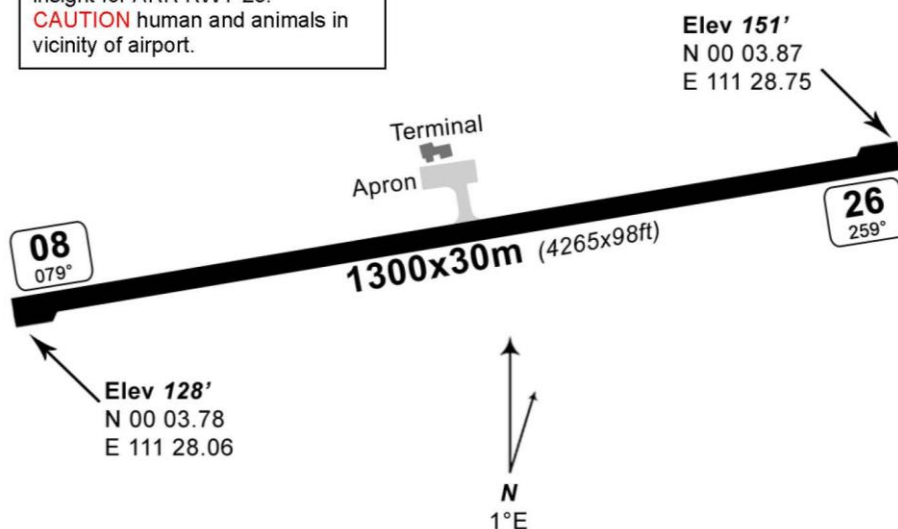
Take off Static  
**CAUTION** Obstacle KELAM HILL at EAST side of Airport.  
**CAUTION** HILL on LEFT side of 54SQG.  
**CAUTION** KELAM HILL must be insight for ARR RWY 26.  
**CAUTION** human and animals in vicinity of airport.

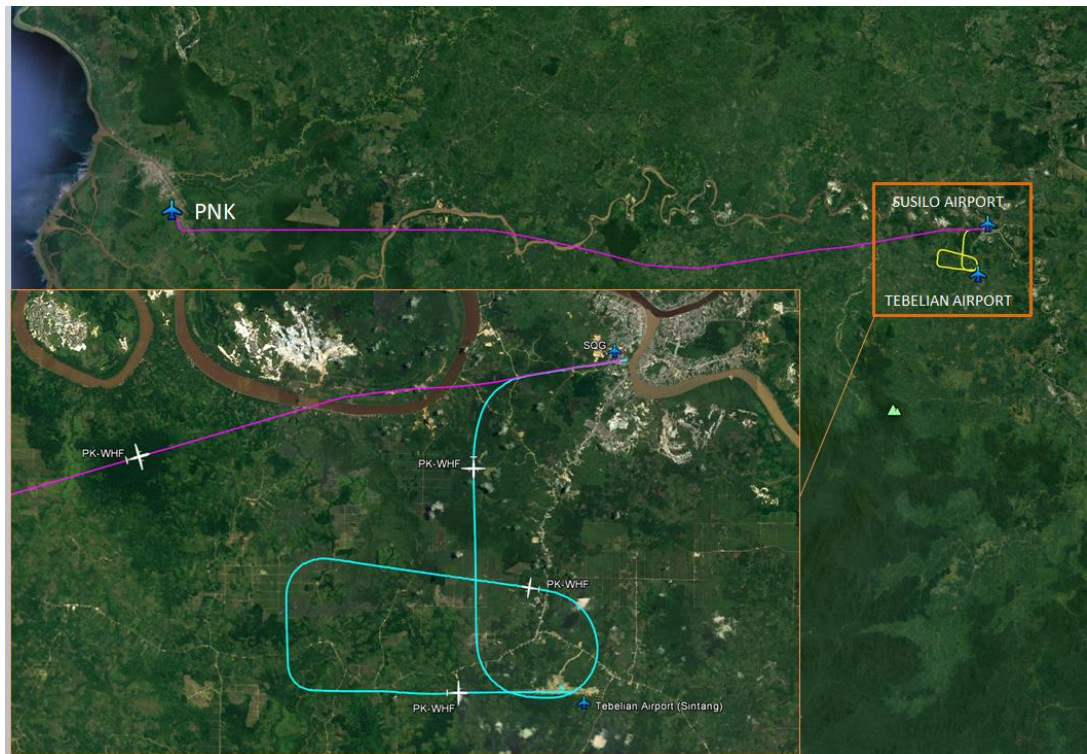
Figure 3: The flight track as recorded on the FDR

The FDR data recorded the occurrence flight and superimposed to Google Earth. The purple line indicated the flight from Pontianak to Susilo Airport, and the blue line indicated the flight from Susilo Airport to Tebelian Airport.

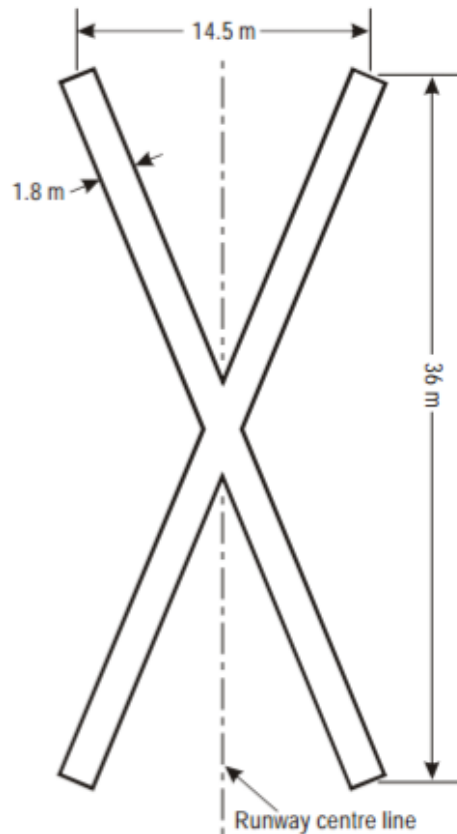
**Figure 4: The illustration of closed runway marking**

The MOS Part 139 Volume I chapter 7.1 described a closed marking shall be displayed on a runway which is permanently closed. The closed marking shall be placed at each end of the runway and shall be of the form and proportions as detailed in the figure 4. When a runway is permanently closed, all normal runway markings shall be obliterated.

The investigation did not find the oversight system to ensure a closed airport has met the requirement standard.
