**KNKT Immediate Safety Recommendation**  
**Aircraft Serious Incident Investigation**  
**PT Sayap Garuda Indah, Bell 407, PK-ZGL**  
**Denpasar, 4 May 2026**

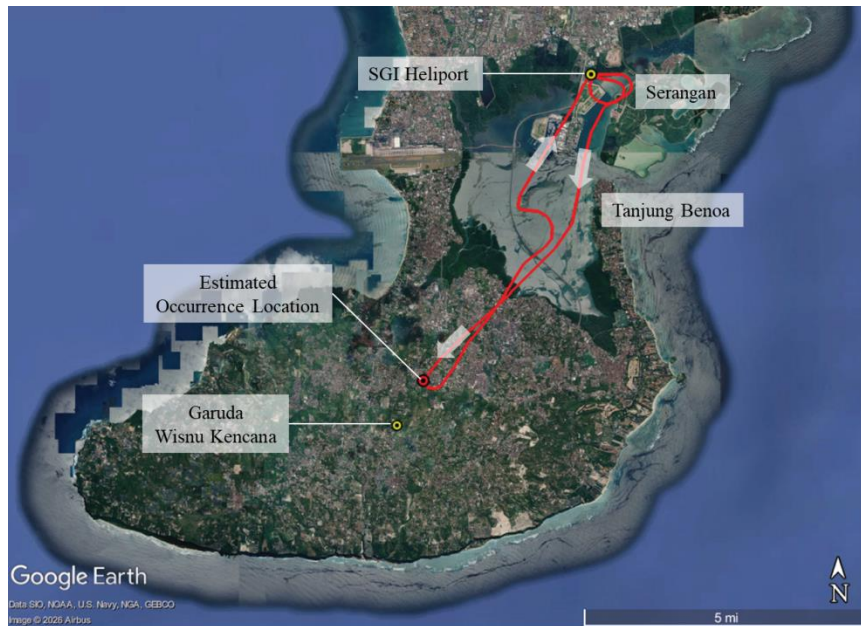
**Figure 1: Estimated occurrence location**

At approximately 1 nautical mile (NM) before reaching GWK, the pilot noticed a momentary decrease in airspeed and heard an abnormal sound originating from the main rotor blade area. The sound lasted for approximately five seconds before ceasing.
