**NATIONAL TRANSPORTATION SAFETY COMMITTEE**  
**REPUBLIC OF INDONESIA**

**FINAL**  
**KNKT.16.11.15.03**

**Marine Accident Investigation Report**  
**Collision between Cargo Ship *TAY SON 4* (IMO 9370587)**  
***and Fishing Vessel *MULYA JATI****  
**Tuban Waters, East Java**  
**Republic of Indonesia**  
**19 November 2016**

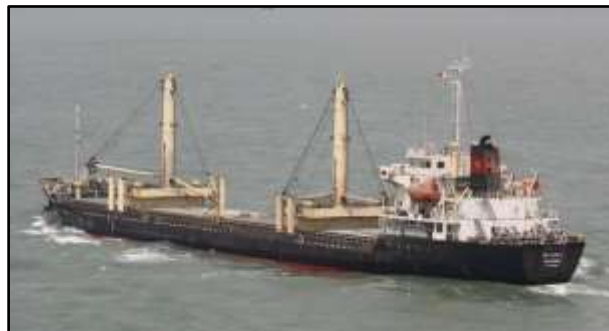
**Figure 5: Tay Son 4**

Propulsive power was provided by two four stroke, single acting, Daihatsu 8DKM-28 diesel engines each with a maximum continuous rating of 2,500 kW at 750 RPM. Each engine was clutched into a reduction gearbox which, in turn, drove a fixed pitch propeller. The ship had a service speed of 13.5 knots at a shaft rotation speed of 190 RPM.

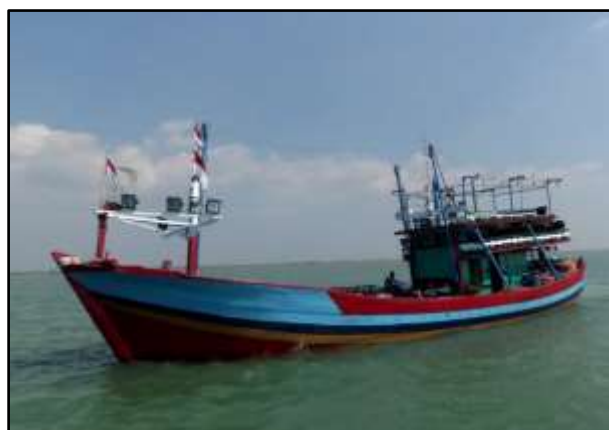
**Figure 6: Mulya Jati**

She had very limited equipment on board as there was no compulsory to do so. Therefore, she had neither automatic identification system (AIS) nor radar. However, she had a GPS and fish finder. The working lights on the foremast masts and top of superstructure were for fishing purposes, instead for navigation. She had navigation lights for preventing collisions at sea, but were dimmer than the lights on a big ship.
