# **FINAL REPORT**

**Marine Accident Investigation Report**

**Grounding of *Young Yong* (IMO 9194127)**

**26 October 2022**

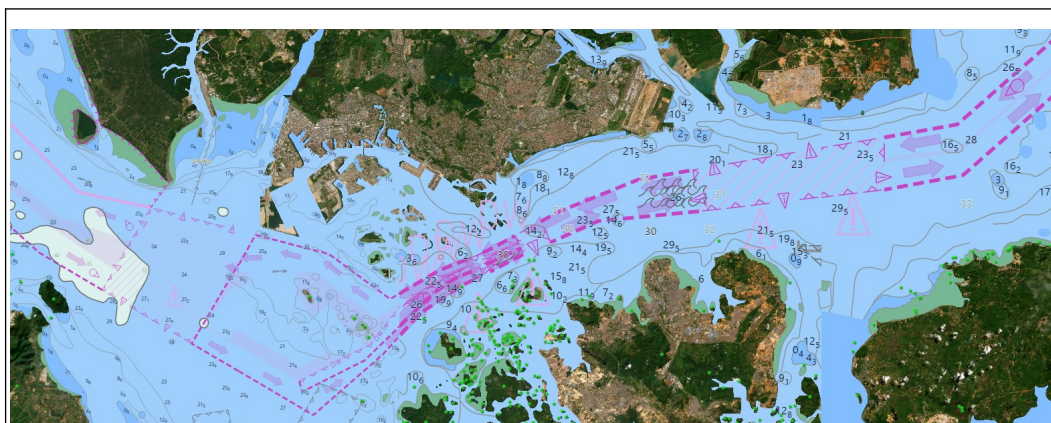
*Figure 12: Eastbound and westbound lanes in the Singapore Strait (image: Pushidrosal).*

Based on the traffic direction, the TSS in the Singapore Strait is divided into two lanes. The westbound lane is located in the upper of the TSS, while the eastbound lane is located in the lower of the TSS.

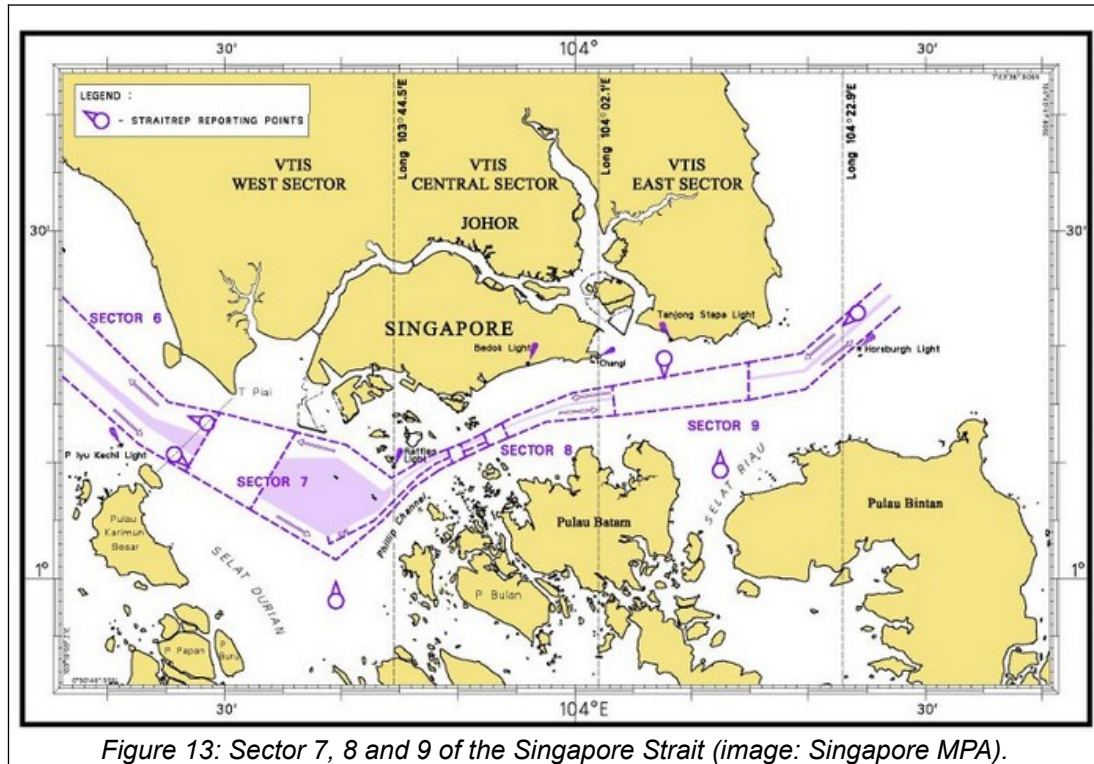
Figure 13: Sector 7, 8 and 9 of the Singapore Strait (image: Singapore MPA).

The TSS in the Singapore Strait has a variety of depth. There is a deep water route in the eastbound lane (middle side of the TSS) to make room for large vessels passing the TSS safely. In Sector 7, there is Nipa Anchorage Area (Indonesian waters) between westbound and eastbound lanes.
